Case study fruit preparation

Reconstruction with Plastifloor® at
Lockwitzer Frischfrucht GmbH, Dresden

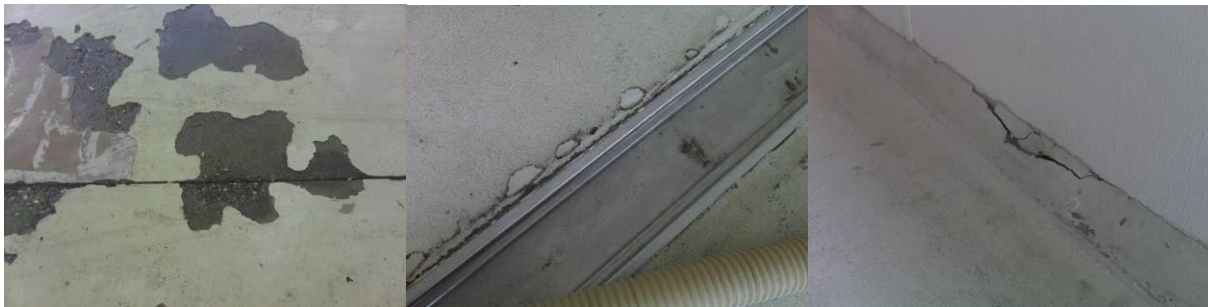
The following pictures show the situation on-site: As in many similar cases, the main contractor had chosen the “cheapest” sub-contractor for preparing the new construction. An EP based KH-coating with a thickness of 2-3 mm was had been installed. Already after a short usage period, the floor showed spallings around inlets, inlet gutters and wall-floor junction. The selected joint construction was leaky and thus inappropriate for a wet operation.

EP coating is spalling

Gutter junctions have spalled

Cove dismantles from the wall

As the slope situation had neither been paid attention to during the new construction, the defective EP coating needed to be milled off as well. The existing joints were cut free. Finally the concrete was shot-blast and dried before the new Plastifloor® floor could be installed.

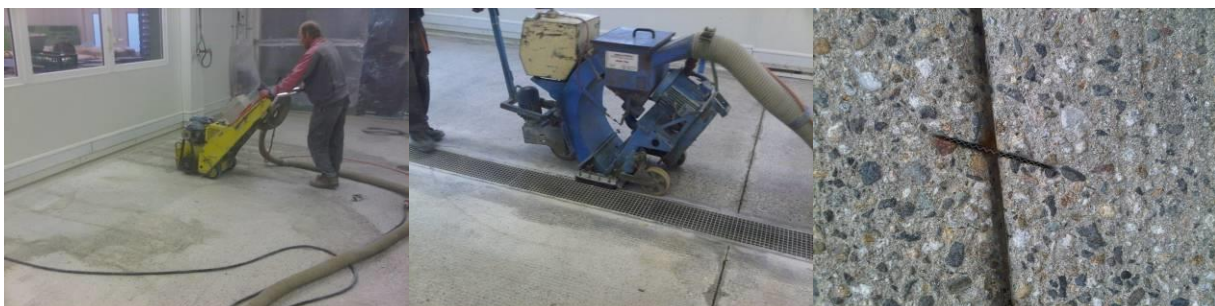
Milling off the EP coating

Shot-blasting

Joints are cramped

The prepared subsurface has now an adhesive tensile strength of 1.5 N/mm². This value is required for ensuring an adhesion of the coating system onto the subsurface. Afterwards the floor has been dried and primed with Plastifloor® 112 0.4 kg/m². Partially the screed needed to be revised with a KH-mortar slope wedge made of Plastifloor® 510 and mortar mix C2 in order to guarantee the

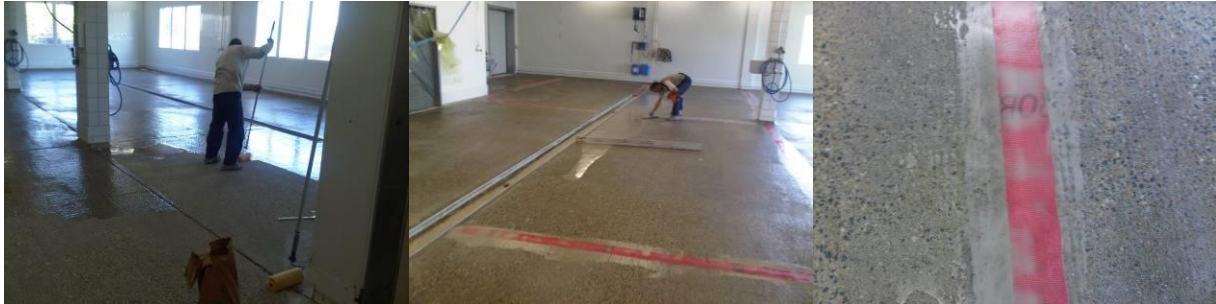
Priming with Plastifloor® 112

Reworking the slope

Casting joints

proper drainage of accumulating water. The inlet gutters were looped-in professionally for ameliorating side adhesion. Afterwards the joints needed to be cast with Plastifloor® 332 and covered with polyester fibre.

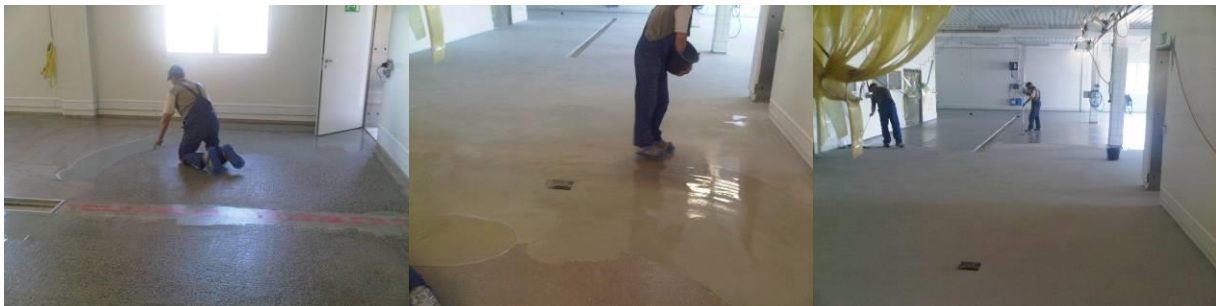
Installing the membrane

Broadcasting the top coat

Sealing with Plastifloor® 526

Then followed the installation of an elastic membrane Plastifloor® 332/z, approx. 3.0 kg/m². This flexible, shock absorbing interlayer allows a jointless and permanently crack-free installation of the new resin coating made of Plastifloor® 410. For achieving the required slip-resistance class R 11, the wet coating is being broadcast with colour quartz sand - size 0.4 – 0.8 mm – before applying the head sealing Plastifloor® 526, approx. 0.6 kg/m². The advantage of the Plastifloor® floor coating is obvious: Due to the short curing times between the single layers, reconstruction works can be effected by a specialized company within a very short time slot. Thus the customer saves precious time and expenses that would result from a loss of production. For example a new tile floor cannot be strained immediately after installation and the problems with joints that are quickly washed out by cleaning will emerge again after a short period of time. Epoxy resins are thermoset materials – they do not withstand the thermal strain by hot and cold water exposure in a grocery plant.

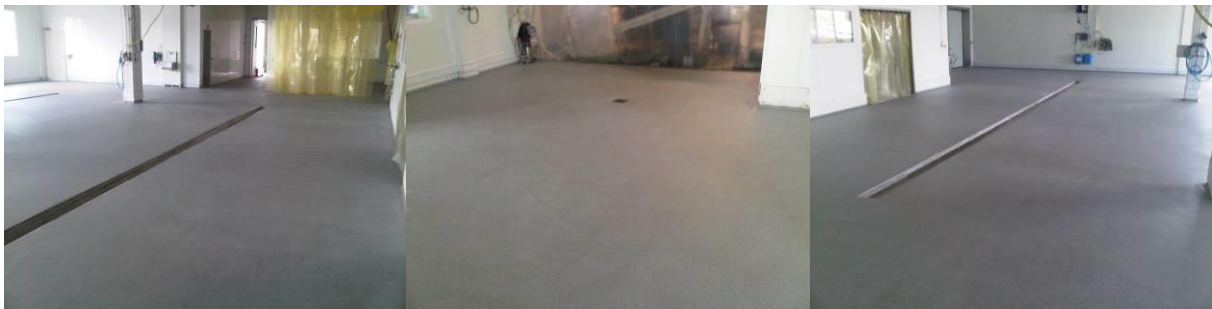
The result is convincing:

The floor reconstruction has been effected by an authorized flooring contractor from Friday 12.00 o'clock until Sunday 17.00 o'clock:
