## Case study garage coating

Reconstruction of a double garage with Plastifloor®  
in only 8 hours

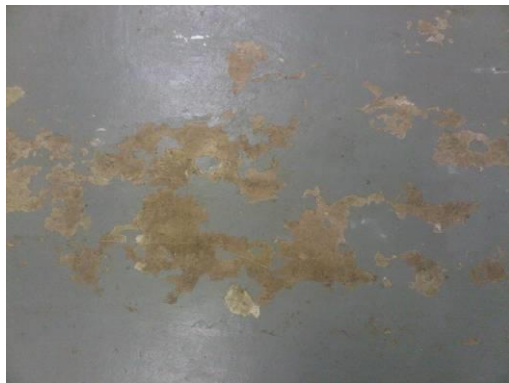
The following pictures show the situation on site: The double garage has been coated with an epoxy resin paint that was already peeling off. Additionally, numerous cracks and warpings were showing in the substrate that had to be evened out.

The old EP coating is peeling off

At first, the defective EP coating needed to be shot-blast, the existing joints, cracks and junctions needed to be cut in in order to increase flank adhesion. Finally the substrate was cleaned with a vacuum cleaner before the new Plastifloor® floor could be installed.

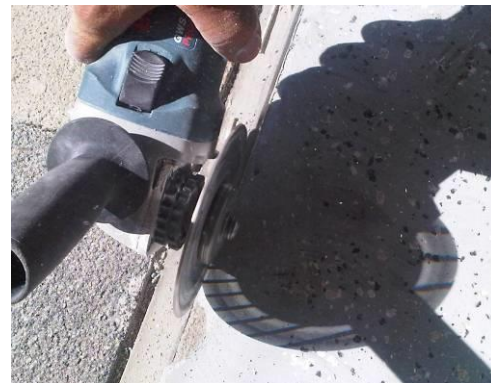
Junctions are being cut in

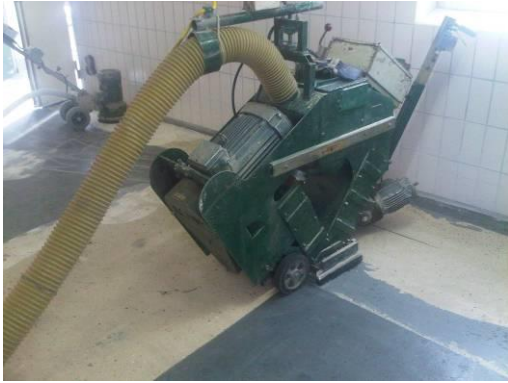
Shot-blasting

The prepared subsurface has now an adhesive tensile strength of 1.5 N/mm<sup>2</sup>. This value is required for ensuring an adhesion of the coating system onto the subsurface. Afterwards the floor has been primed with Plastifloor® 112, 0.4 kg/m<sup>2</sup>. Partially the screed needed to be revised with a KH-mortar slope wedge made of Plastifloor® 510 and mortar mix B2 in order to produce an even surface corresponding to DIN 18202. In order to close the cracks in the substrate, the newly developed plasto – elastic filler PET was used in this application. This filler combines the ductile properties of the PET-granulate with the elastic properties of Plastifloor® membrane resin 332.

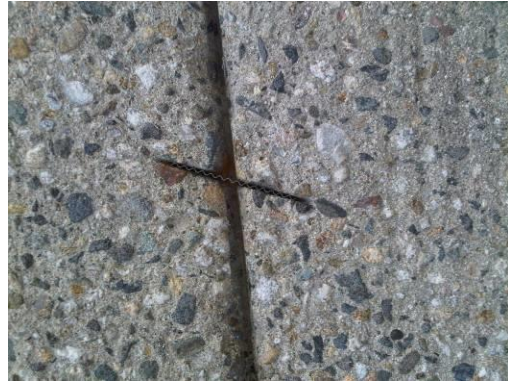
Joints are cramped

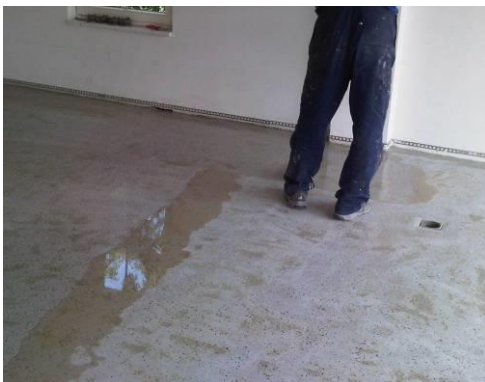
Priming with Plastifloor® 112

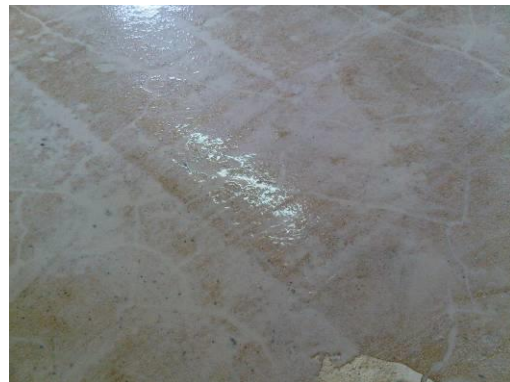
Cracks are sealed with Plastifloor® 510

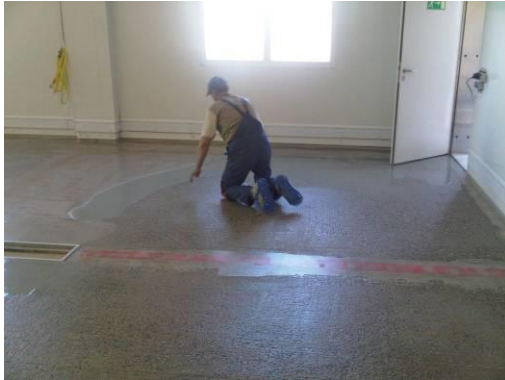
Installing the membrane

Then followed the installation of an elastic membrane Plastifloor® 332/z, approx. 2.0 kg/m<sup>2</sup>. This flexible, shock absorbing interlayer allows a jointless and permanently crack-free installation of the new resin coating made of Plastifloor® 410. For achieving the required slip-resistance class R 11, the wet coating is being broadcast with colour quartz sand - size 0.4 – 0.8 mm, before applying the head sealing Plastifloor® 522, approx. 0.6 kg/m<sup>2</sup>.

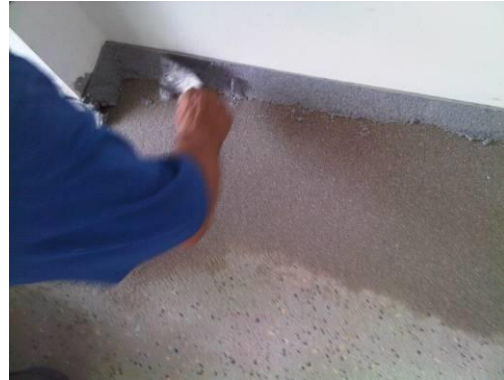
Installing the cove

With the **Plastifloor®** floor coating system by Plasti-Chemie International GmbH, old garage floors can be completely reconstructed in only one day. The garage is being cleared in the morning and subsequently the substrate is being prepared professionally. In order to prevent the walls from getting wet when snow and ice are defrosting, a waterproof cove should be set before installing the **Plastifloor®** floor coating system.

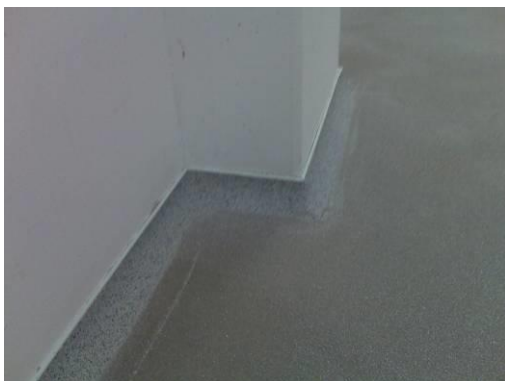
Connection to the wall with membrane

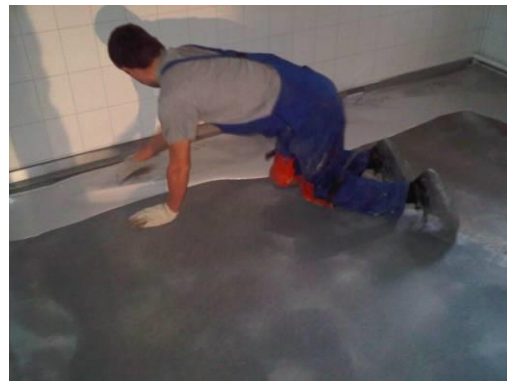
Installation of the coating

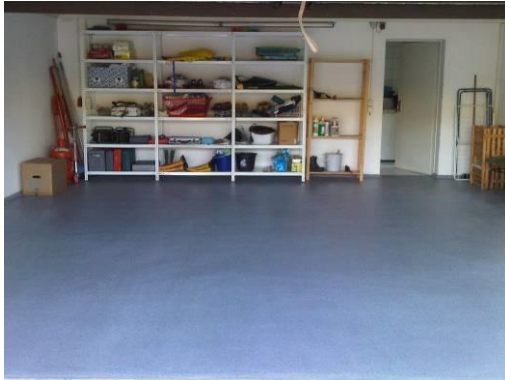
The finished garage floor .

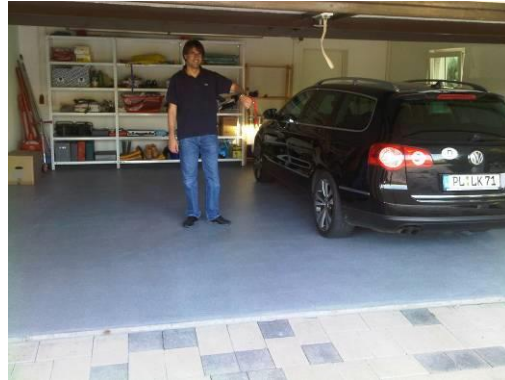
Fully chargeable after only 2 hours.

Already after an installation time of 8 hours the coating is finished and only 2 hours after the last sealing, it can fully be passed over. In addition, the floor is skid-proof, waterproof and available in many colours. Thus, reconstruction of the garage is finished within only one day.
