Case study fruit preparation

Reconstruction with Plastifloor® at
Lockwitzer Frischfrucht GmbH, Dresden

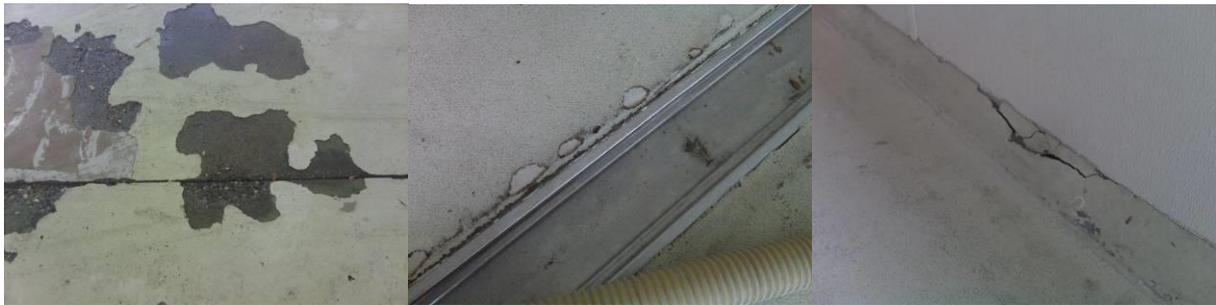
The following pictures show the situation on-site: As in many similar cases, the main contractor had chosen the "cheapest" sub-contractor for preparing the new construction. An EP based KH-coating with a thickness of 2-3 mm was had been installed. Already after a short usage period, the floor showed spallings around inlets, inlet gutters and wall-floor junction. The selected joint construction was leaky and thus inappropriate for a wet operation.

EP coating is spalling

Gutter junctions have spalled

Cove dismantles from the wall

As the slope situation had neither been paid attention to during the new construction, the defective EP coating needed to be milled off as well. The existing joints were cut free. Finally the concrete was shot-blasted and dried before the new Plastifloor® floor could be installed.

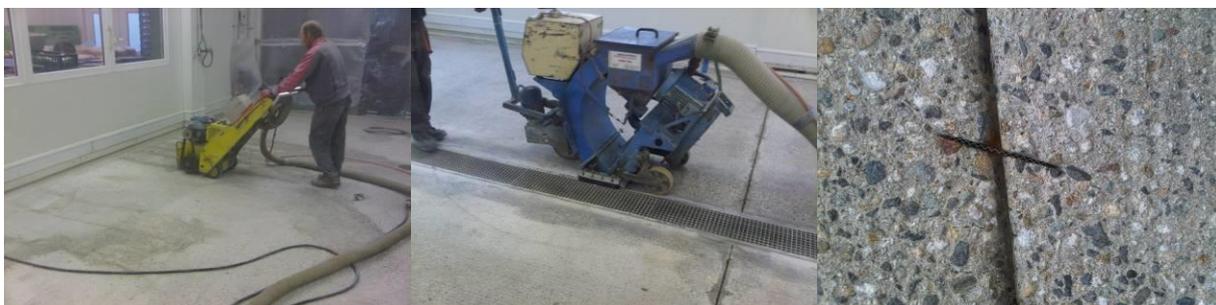
Milling off the EP coating

Shot-blasting

Joints are cramped

The prepared subsurface has now an adhesive tensile strength of 1.5 N/mm². This value is required for ensuring an adhesion of the coating system onto the subsurface. Afterwards the floor has been dried and primed with Plastifloor® 112 0.4 kg/m². Partially the screed needed to be revised with a
10.02.2014

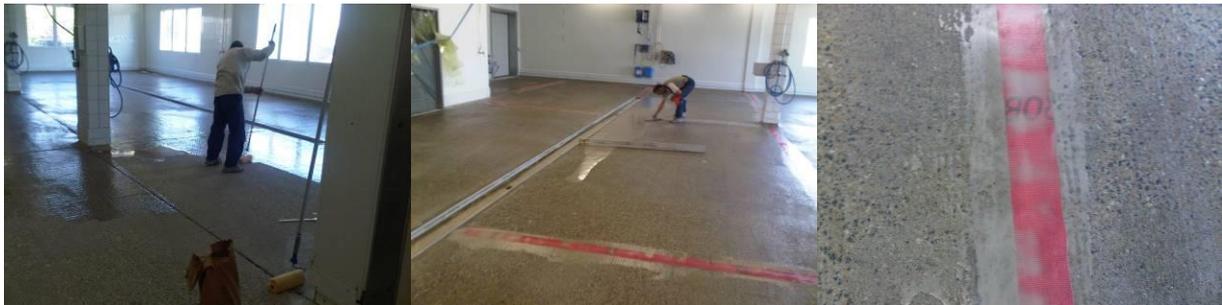
Priming with Plastifloor® 112

Reworking the slope

Casting joints

KH-mortar slope wedge made of Plastifloor® 510 and mortar mix C2 in order to guarantee the proper drainage of accumulating water. The inlet gutters were looped-in professionally for ameliorating side adhesion. Afterwards the joints needed to be cast with Plastifloor® 332 and covered with polyester fibre.

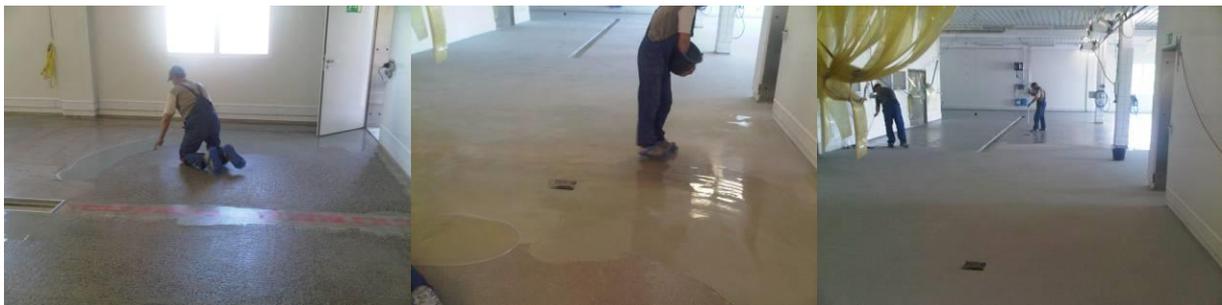
Installing the membrane

Broadcasting the top coat

Sealing with Plastifloor® 526

Then followed the installation of an elastic membrane Plastifloor® 332/z, approx. 3.0 kg/m². This flexible, shock absorbing interlayer allows a jointless and permanently crack-free installation of the new resin coating made of Plastifloor® 410. For achieving the required slip-resistance class R 11, the wet coating is being broadcast with colour quartz sand - size 0.4 – 0.8 mm – before applying the head sealing Plastifloor® 526, approx. 0.6 kg/m². The advantage of the Plastifloor® floor coating is obvious: Due to the short curing times between the single layers, reconstruction works can be effected by a specialized company within a very short time slot. Thus the customer saves precious time and expenses that would result from a loss of production. For example a new tile floor cannot be strained immediately after installation and the problems with joints that are quickly washed out by cleaning will emerge again after a short period of time. Epoxy resins are thermoset materials – they do not withstand the thermal strain by hot and cold water exposure in a grocery plant.

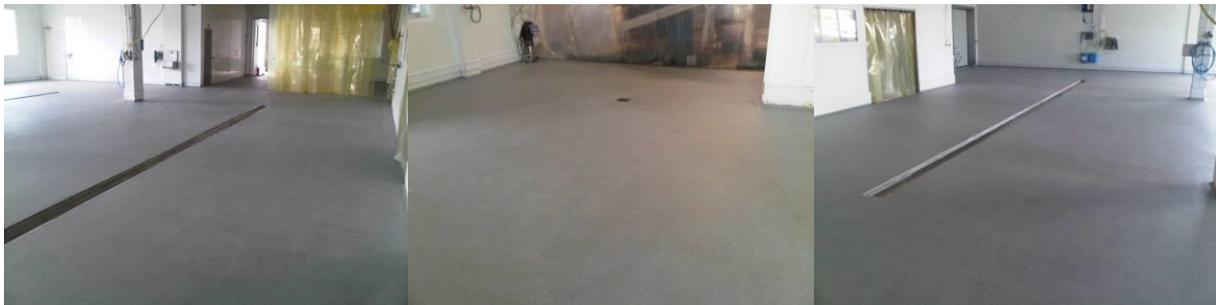
The result is convincing:
