## Case study beer brewery

Reconstruction with Plastifloor® at  
Hösl Brewery, Mitterteich Bavaria/Germany

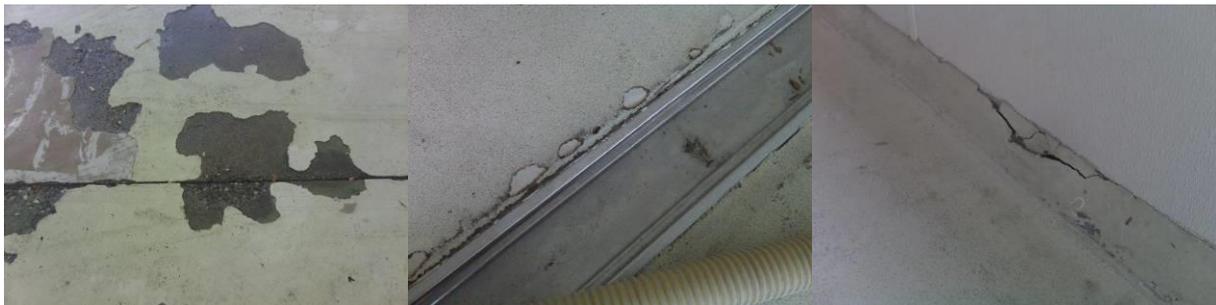
The following pictures show the situation on-site: As in many similar cases, the main contractor had chosen the "cheapest" sub-contractor for preparing the new construction. An EP based Coating with a thickness of 2-3 mm was had been installed. Already after a short usage period, the floor showed spallings around inlets, inlet gutters and wall-floor junction. The selected joint construction was leaky and thus inappropriate for a wet operation.

EP coating is spalling

Gutter junctions have spalled

Cove dismantles from the wall

As the slope situation had neither been paid attention to during the new construction, the defective EP coating needed to be milled off as well. The existing joints were cut free. Finally the concrete was shot-blasted and dried before the new Plastifloor® floor could be installed.

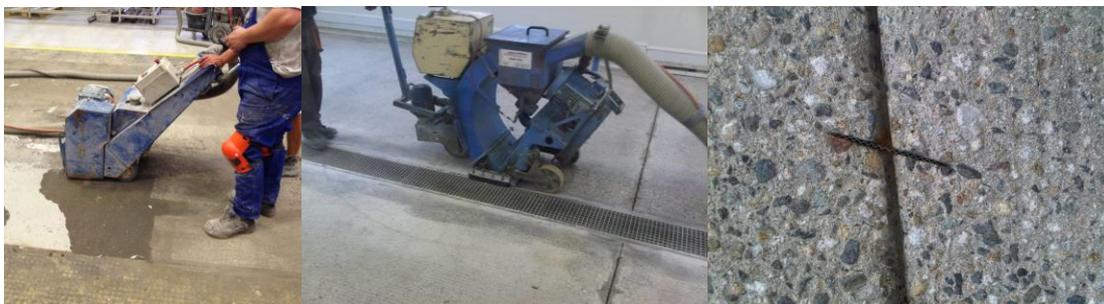
Milling off the EP coating

Shot-blasting

Joints are cramped

The prepared subsurface has now an adhesive tensile strength of 1.5 N/mm<sup>2</sup>. This value is required for ensuring an adhesion of the coating system onto the subsurface. Afterwards the floor has been dried and primed with Plastifloor® 112 0.4 kg/m<sup>2</sup>.

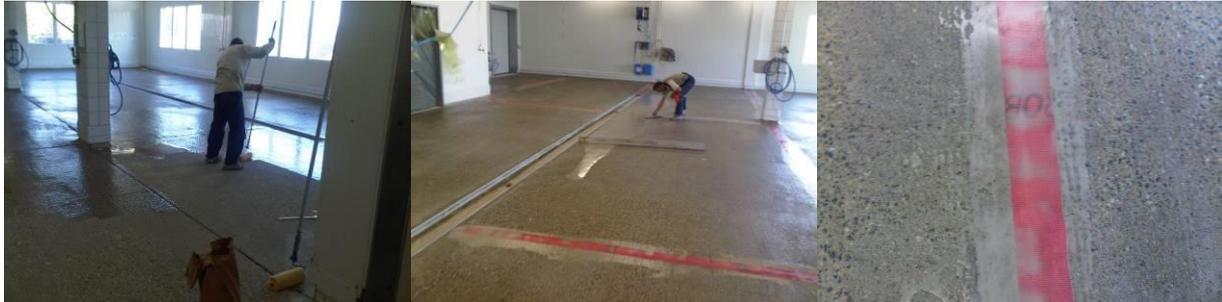
Priming with Plastifloor® 112

Reworking the slope

Casting joints

Partially the screed needed to be revised with a KH-mortar slope wedge made of Plastifloor® 510 and mortar mix C2 in order to guarantee the proper drainage of accumulating water. The inlet gutters were looped-in professionally for ameliorating side adhesion. Afterwards the joints needed to be cast with Plastifloor® 332 and covered with polyester fibre.

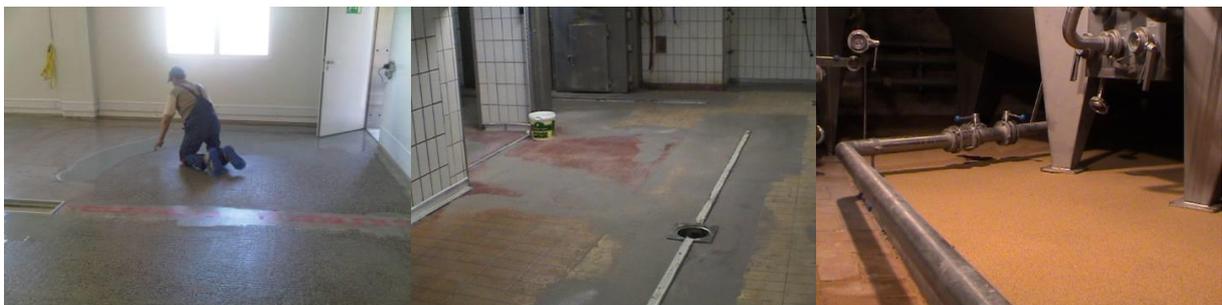
Installing the membrane

preparing the drains

Sealing with Plastifloor® 526

Then followed the installation of an elastic membrane Plastifloor® 332/z, approx. 3.0 kg/m<sup>2</sup>. This flexible, shock absorbing interlayer allows a jointless and permanently crack-free installation of the new resin coating made of Plastifloor® 410. For achieving the required slip-resistance class R 11, the wet coating is being broadcast with colour quartz sand - size 0.4 – 0.8 mm – before applying the head sealing Plastifloor® 526, approx. 0.6 kg/m<sup>2</sup>. The advantage of the Plastifloor® floor coating is obvious: Due to the short curing times between the single layers, reconstruction works can be effected by a specialized company within a very short time slot. Thus the customer saves precious time and expenses that would result from a loss of production. For example a new tile floor cannot be strained immediately after installation and the problems with joints that are quickly washed out by cleaning will emerge again after a short period of time. Epoxy resins are thermoset materials – they do not withstand the thermal strain by hot and cold water exposure in a grocery plant.

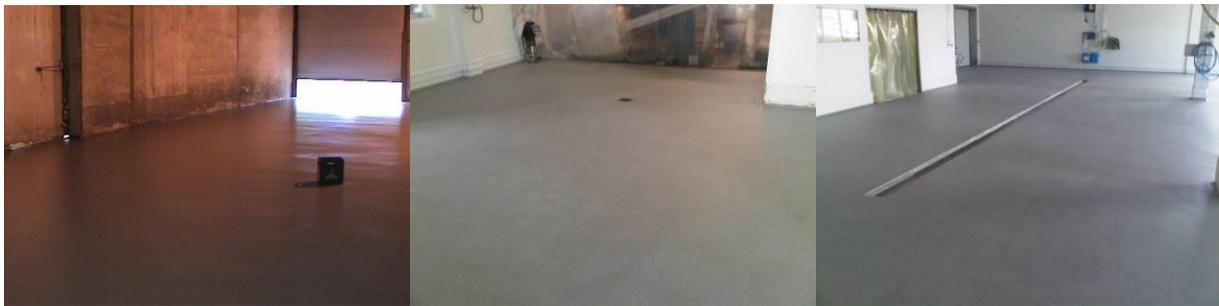
The result is convincing:

Production could start again on Monday.
